526 New Britain Road

1985 Townwide Historic and Architectural Survey of Berlin, Connecticut. Survey # 125

HISTORIC RESOURCES INVENTORY
BUILDING AND STRUCTURES
HIST-6 NEW 5/77

IDENTIFICATION		DESCRIPTION	
1. BUILDING NAME (Common)		1. BUILDING NAME (Historic)	
Otto Foglestrand House		Otto Foglestrand House	
2. TOWN CITY	VILLAGE	COUNTY	
Berlin	Kensington	Hartford

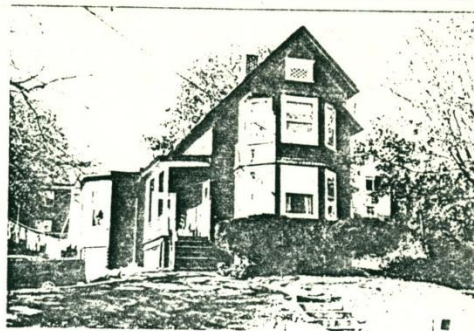
A two-story semi-octagonal bay projects from the Otto Foglestrand House's narrow gable-end facade; above is an overhanging gable-roofed attic story supported at the rake ends with large jigsaw brackets with turned pendants and incised floral designs. Scalloped shingles have been applied between stories and the gable peak. The rectangular attic window has diamond-pane sash. Other windows have diamond-pane upper sashes and single-pane lower sashes. Both left and right elevations have at the rear one-story flat-roofed semi-hexagonal extensions. On the left, a one-story flat-roofed porch leads to a side entry in the front of the wing. The porch features a cut-out slat railing with diamond and arrow motifs, square posts, and a drilled frieze.

Architecturally, the Otto Foglestrand House is significant as one of the best and most original examples of Victorian Vernacular architecture. Elaborate wooden decoration, made affordable by 19th-century advances in wood-forming technology, is a hallmark of the style. Typical Victorian Vernacular features in the Foglestrand House include the decorative shingles, cut-out slat porch railing, and jigsaw brackets. The diamond-pane sash is more commonly seen in early 20th-century houses, but may well be original. Like the irregular massing of the house and the overhanging attic, it suggests the influence of the Queen Anne style.
